**PRELIMINARY ASSESSMENT/  
VISUAL SITE INSPECTION**

**GENERAL ELECTRIC COMPANY -  
CONNEAUT BASE PLANT  
CONNEAUT, OHIO  
OHD 004 202 735**

**FINAL REPORT**

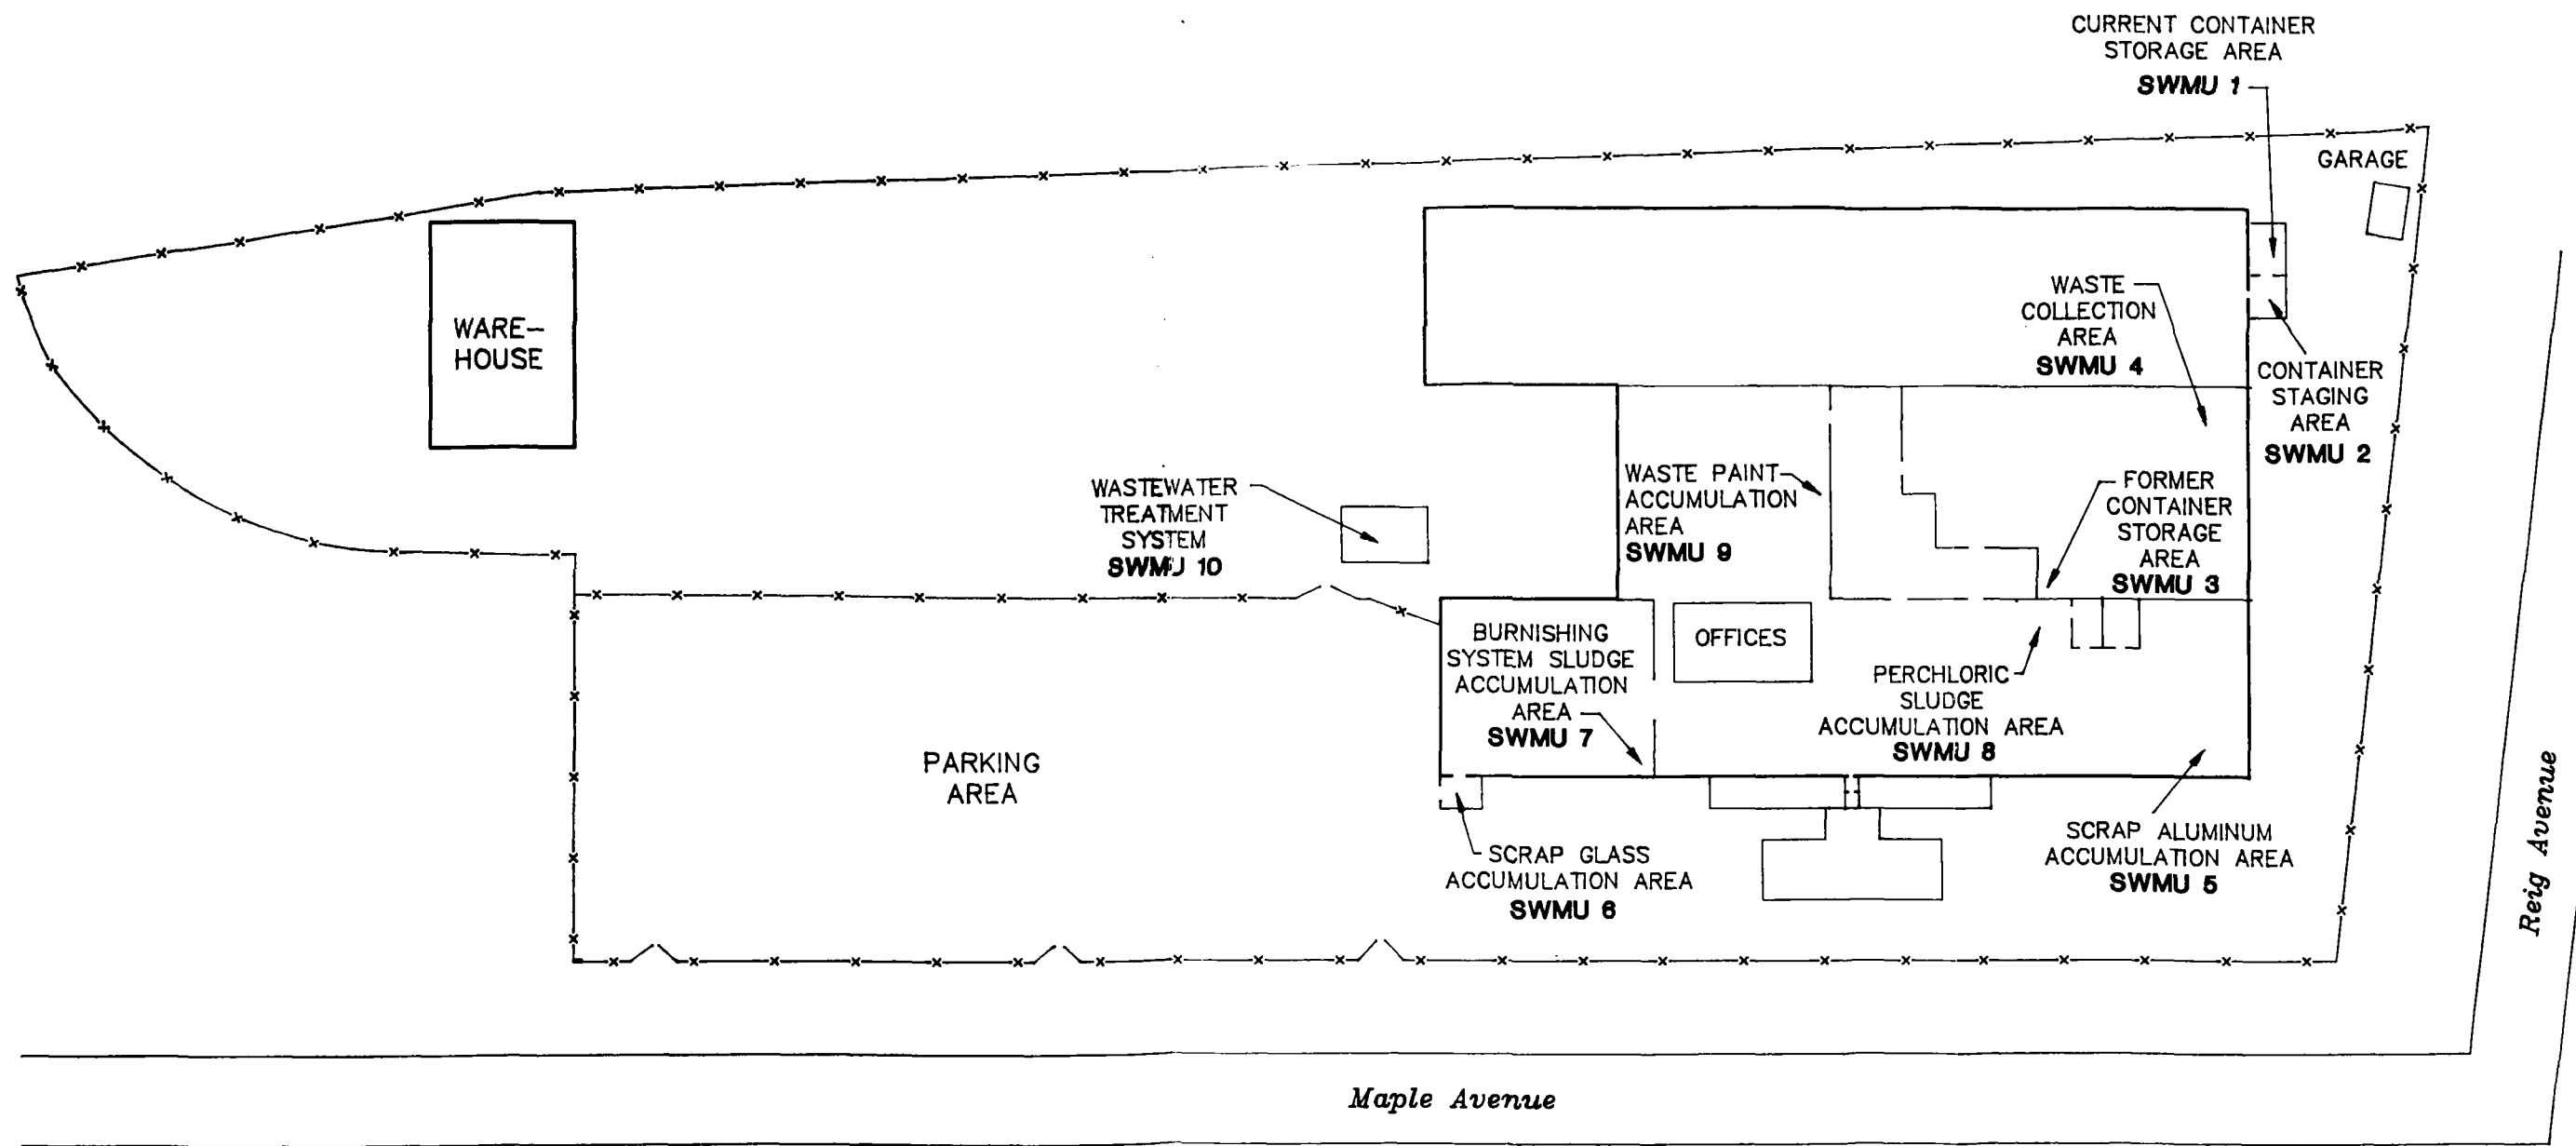
G.E. CONNEAUT BASE PLANT  
CONNEAUT, OHIO

Operations at the CBP facility currently produce eleven waste streams: used oil; used oil with small amounts of antifreeze; used agitene (D001); scrap aluminum; used press oil; scrap glass; burnishing system sludge (D001); perchloric sludge (F001); waste paint (D001); wastewater; and wastewater treatment sludge. The facility's SWMUs are identified in Table 1. The facility layout, including SWMUs, is shown in Figure 2. The facility's waste streams are summarized in Table 2.

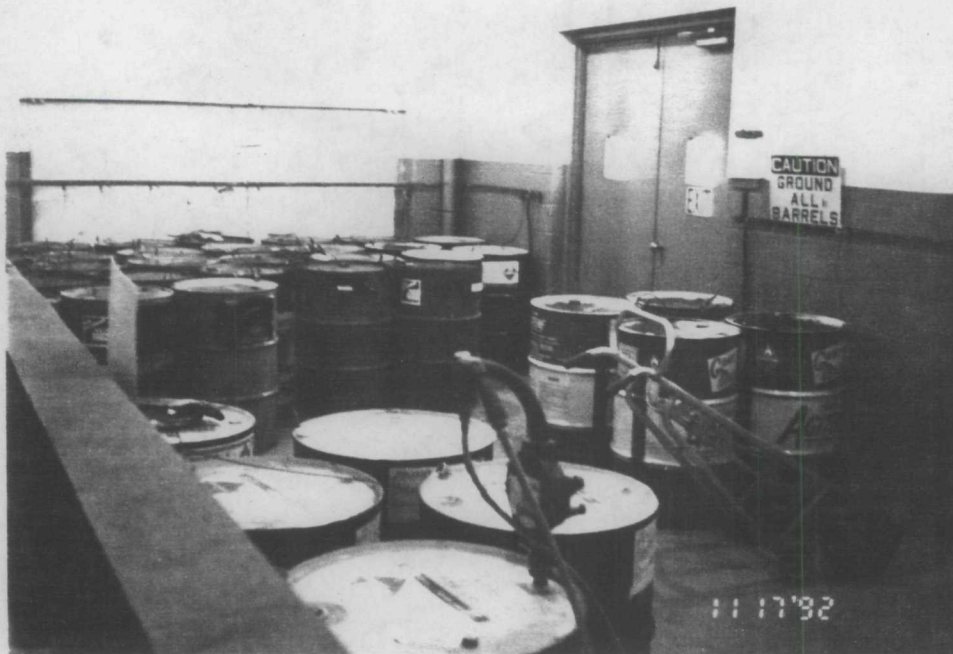
Photograph No. 1  
 Orientation: Northeast  
 Description: Current Container Storage Area

stored closed. A cabinet containing products such as paint and solvent was also located in this area. The concrete floor of this unit did not appear to be cracked. PRC noted no evidence of release (see Photograph No. 1).

Location: SWMU 1  
 Date: 11/17/92

**Recommendations:**      PRC recommends no further action for SWMUs 1, 2, and 4 at this time.

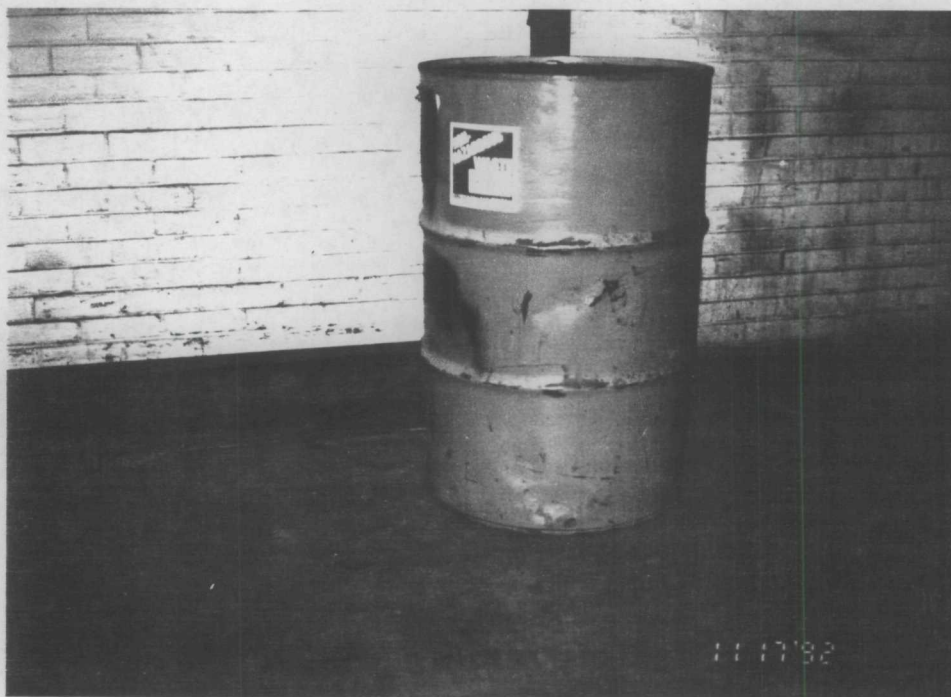
Photograph No. 2  
 Orientation: West  
 Description: Container Staging Area

This unit contained one 55-gallon drum of used oil. The concrete floor of this unit did not appear to be cracked. PRC noted no evidence of release (see Photograph No. 2).

Location: SWMU 2  
 Date: 11/17/92

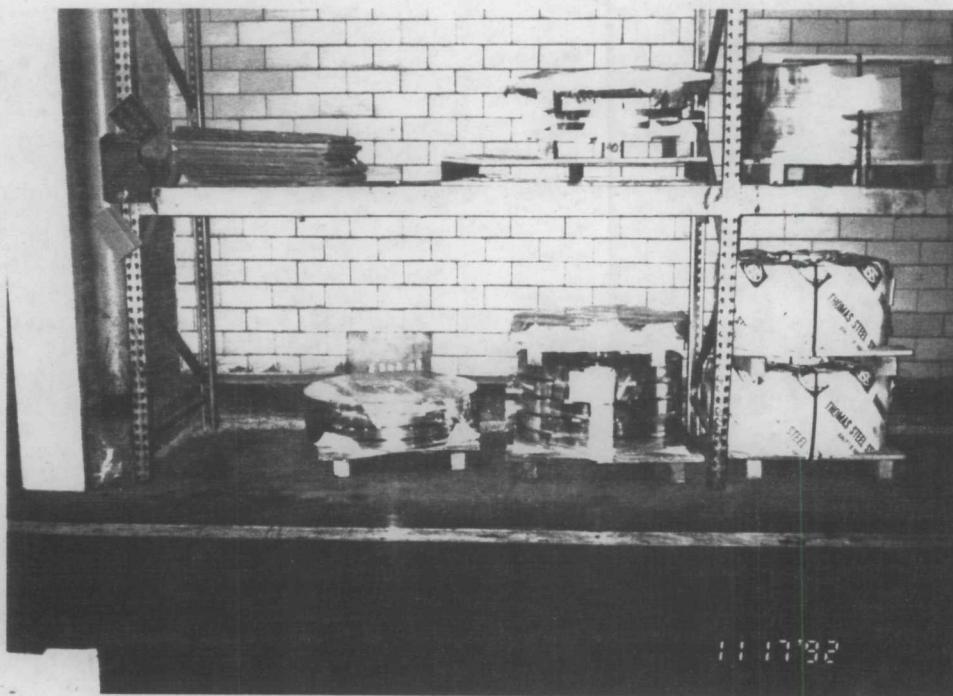
Photograph No. 3

PRC observed the area of this unit and noted that raw materials are now stored at this location (see Photograph No. 3).

Location: SWMU 3

**Recommendations:**      PRC recommends no further action for this SWMU at this time.

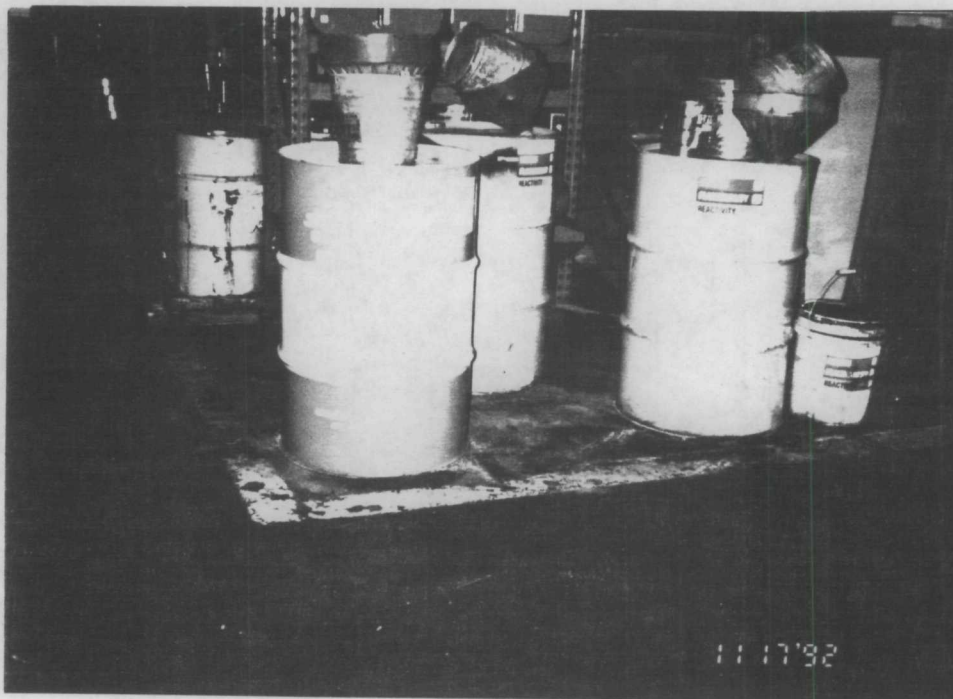
Photograph No. 4

During the VSI, this unit contained three steel 55-gallon drums. One drum contained used oil, the second drum contained used oil with small amounts of used antifreeze, and the third drum contained used agitene (D001). The concrete floor of this unit did not appear to be cracked. PRC noted no evidence of release (see Photograph No. 4).

Location: SWMU 4

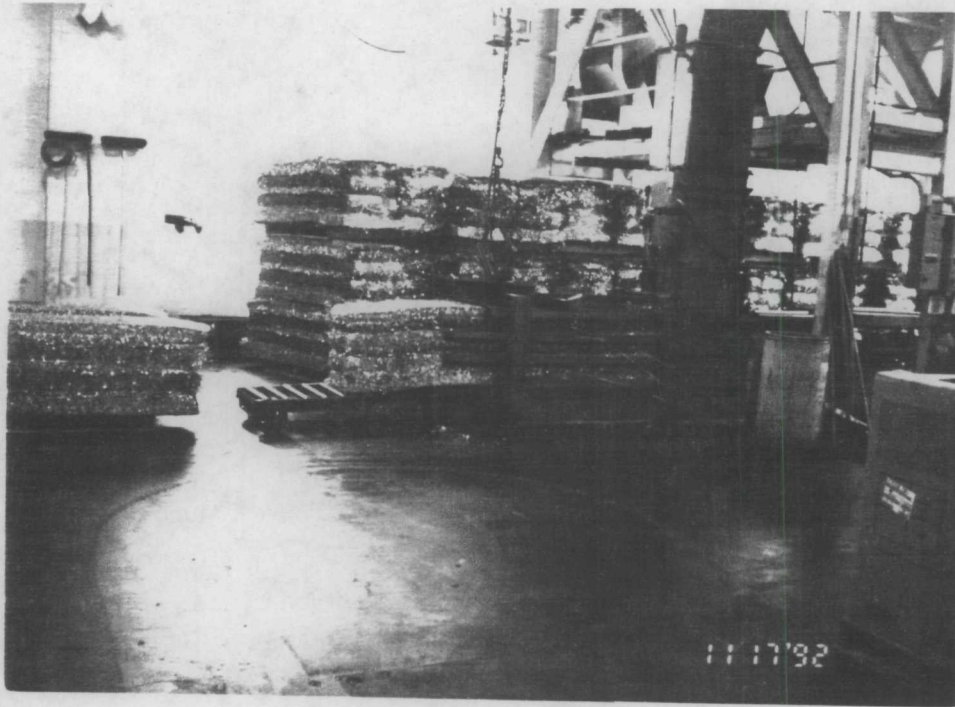
Photograph No. 5  
 Orientation: East  
 Description: Scrap Aluminum Accumulation Area

During the VSI, this unit contained about 50 bales of aluminum on wooden pallets. The concrete floor beneath this unit did not appear to be cracked. PRC noted no evidence of release (see Photograph No. 5).

Location: SWMU 5  
 Date: 11/17/92

**Recommendations:**      PRC recommends no further action for SWMUs 5 and 6 at this time.

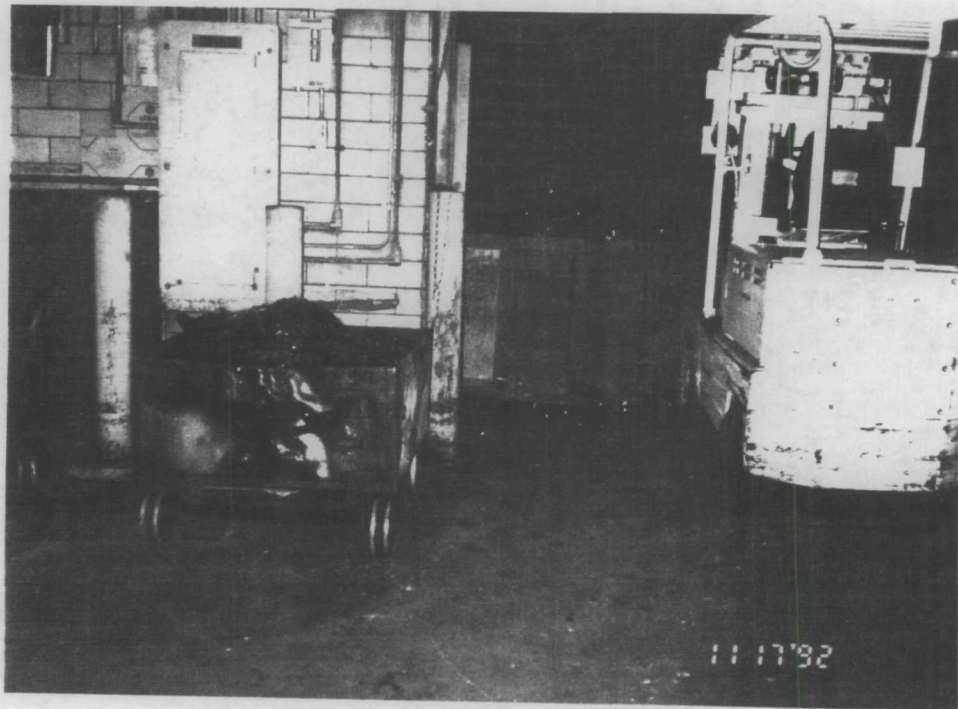
Photograph No. 6  
 Orientation: South  
 Description: Scrap Glass Accumulation Area

During the VSI, a cart measuring approximately 3 by 2 by 2 feet and the roll-off box were filled with scrap glass. The concrete floor near this unit did not appear to be cracked. A small amount of scrap glass was on the floor near the roll-off box (see Photograph No. 6).

Location: SWMU 6  
 Date: 11/17/92

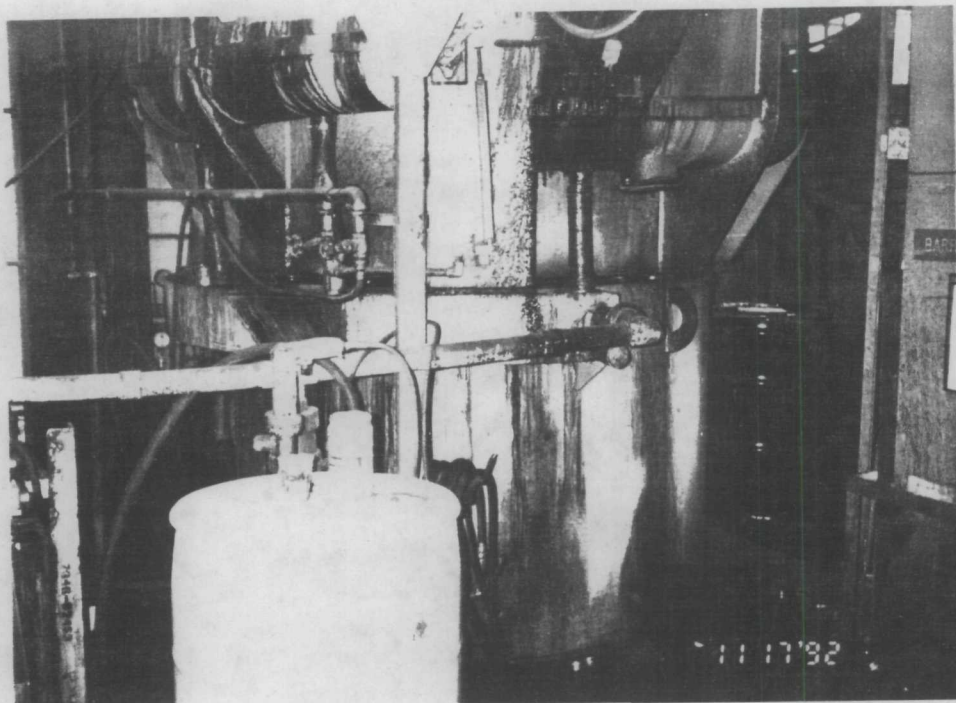
Photograph No. 7

This unit contained about 25 gallons of sludge during the VSI. The cap of the drum was closed. The concrete floor near this unit did not appear to be cracked. PRC noted no evidence of release (see Photograph No. 7).

Description: Burnishing Sludge Accumulation Area; burnishing system sludge is collected in the black steel drum

Location: SWMU 7

**Recommendations:**      PRC recommends no further action for SWMUs 7, 8, and 9 at this time.

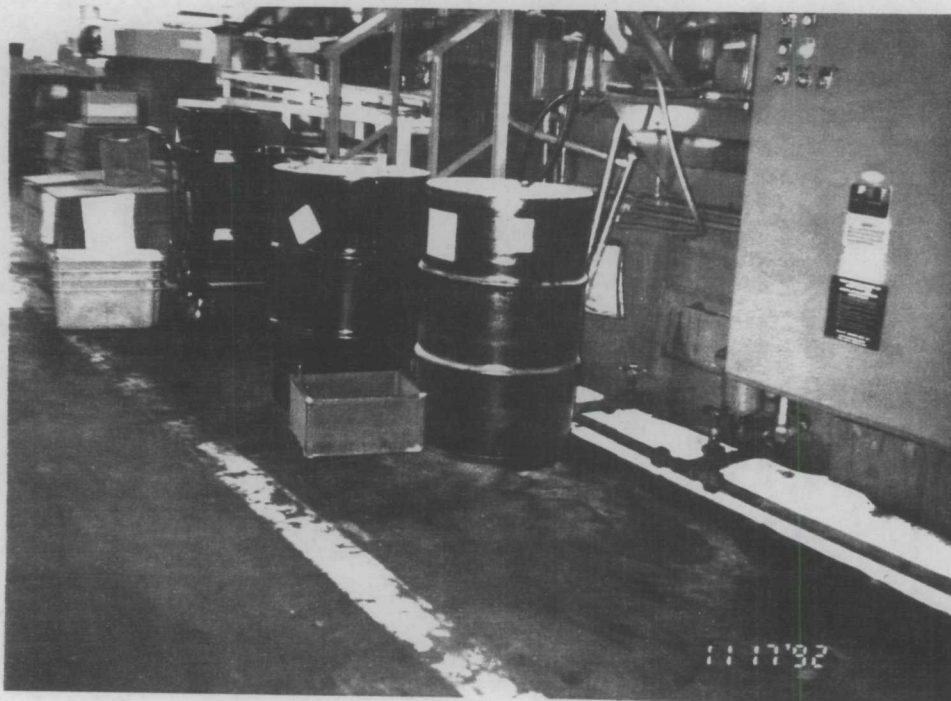
Photograph No. 8

**Observations:** During the VSI, the drum of this unit was closed. The concrete floor near this unit did not appear to be cracked. PRC noted no evidence of release (see Photograph No. 8).

Location: SWMU 8

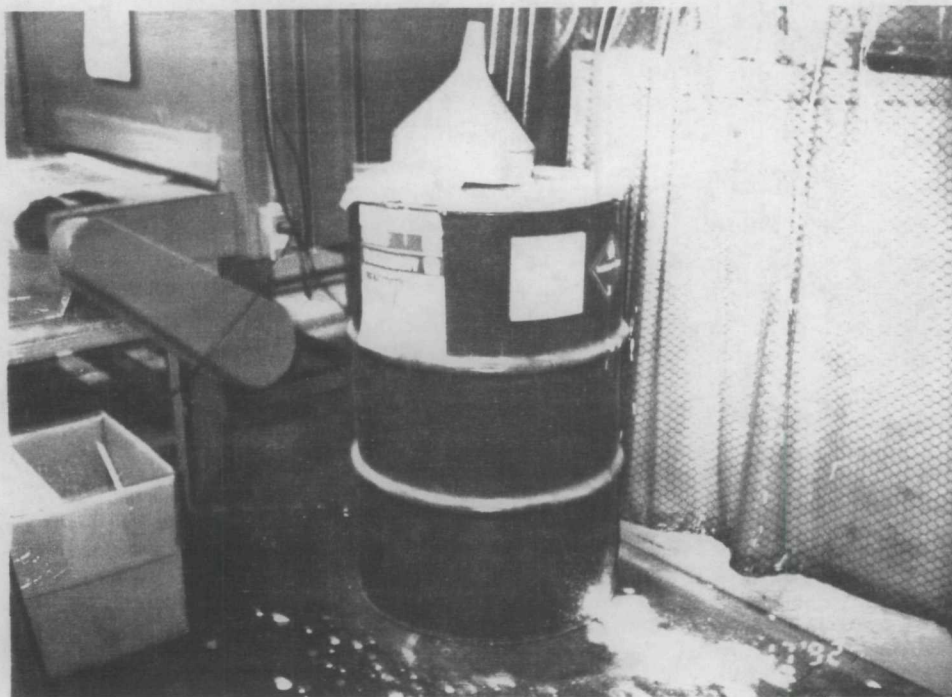
Photograph No. 9

**Observations:** During the VSI, the drum of this unit was closed. The concrete floor near this unit did not appear to be cracked. PRC noted small amounts of paint have stained the floor in this area (see Photograph No. 9).

Description: Waste Paint Accumulation Area; small amounts of paint have stained the floor in this area

Location: SWMU 9

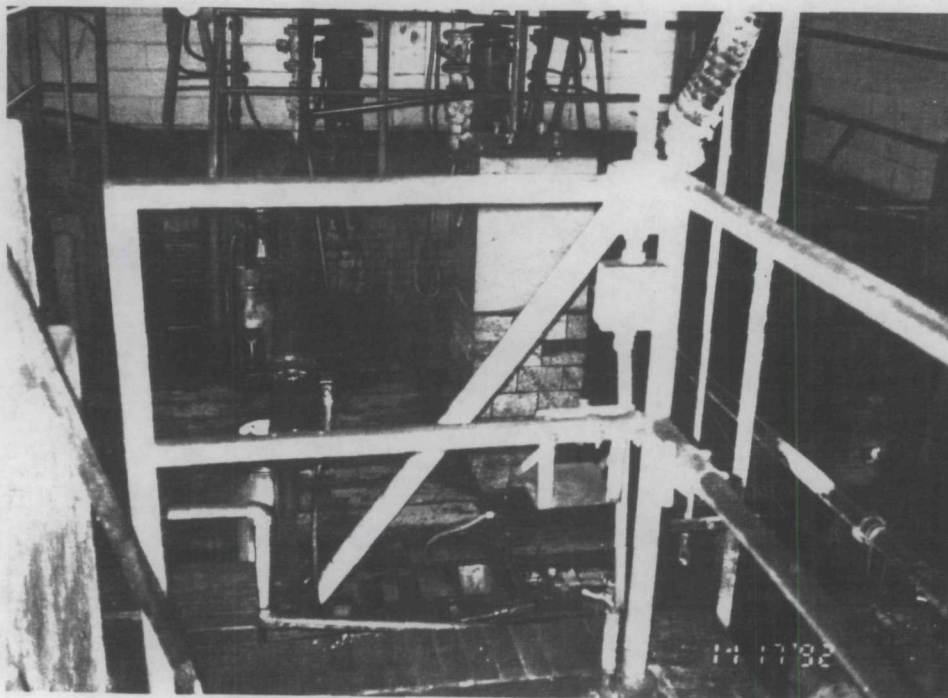
Photograph No. 10

box. PRC noted no evidence of release (see Photographs No. 10 and 11).

Location: SWMU 10

**Recommendations:**      PRC recommends no further action for SWMU 10 at this time.

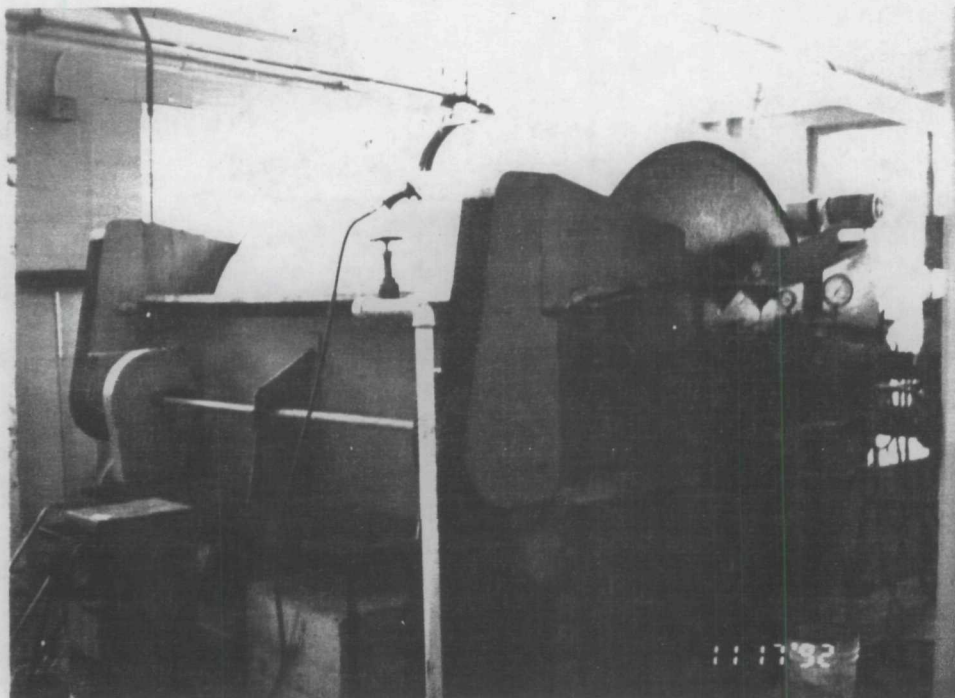
Photograph No. 11  
Orientation: Southwest  
Description: Filter drum of the Wastewater Treatment System

Location: SWMU 10  
Date: 11/17/92
